## Crack Monitoring - Results

**Survey No** 013

## Crack Monitoring - Graphs

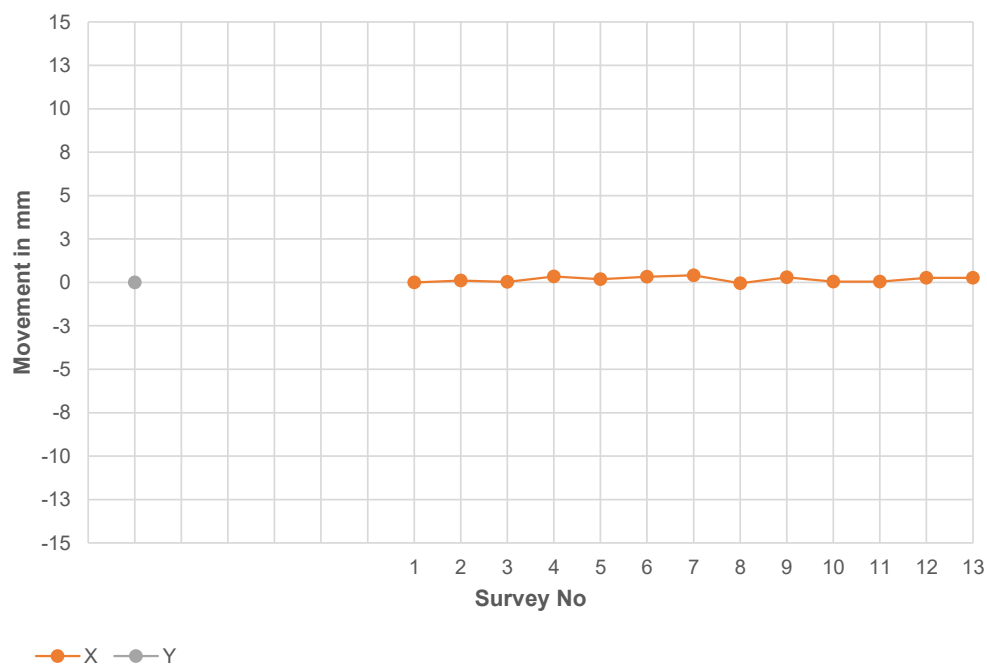
1st Floor - Bedroom opposite top of stairs, flank wall, plinth

| Survey No | Date | X | Y |
| 13 | 26/03/26 | 0.27 | |

| Gauge No | Gauge Type | Location Comment | Readings - Base | | Readings - Surveyed | | Differences | |
|---|---|---|---|---|---|---|---|---|
| D4 | Demec | 1st Floor - Bedroom opposite top of stairs, flank wall, plinth | 38.39 | | 38.66 | | 0.27 | |

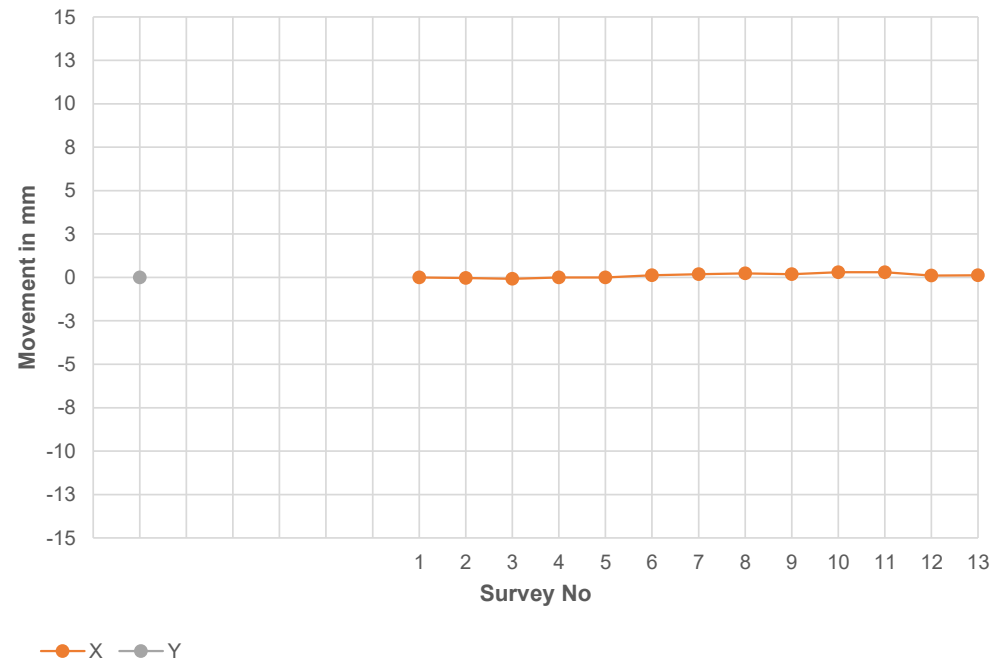
Ground - Lounge, top left of window

| Survey No | Date | X | Y |
| 13 | 26/03/26 | 0.13 | |

| Gauge No | Gauge Type | Location Comment | Readings - Base | | Readings - Surveyed | | Differences | |
|---|---|---|---|---|---|---|---|---|
| D3 | Demec | Ground - Lounge, top left of window | 33.51 | | 33.64 | | 0.13 | |

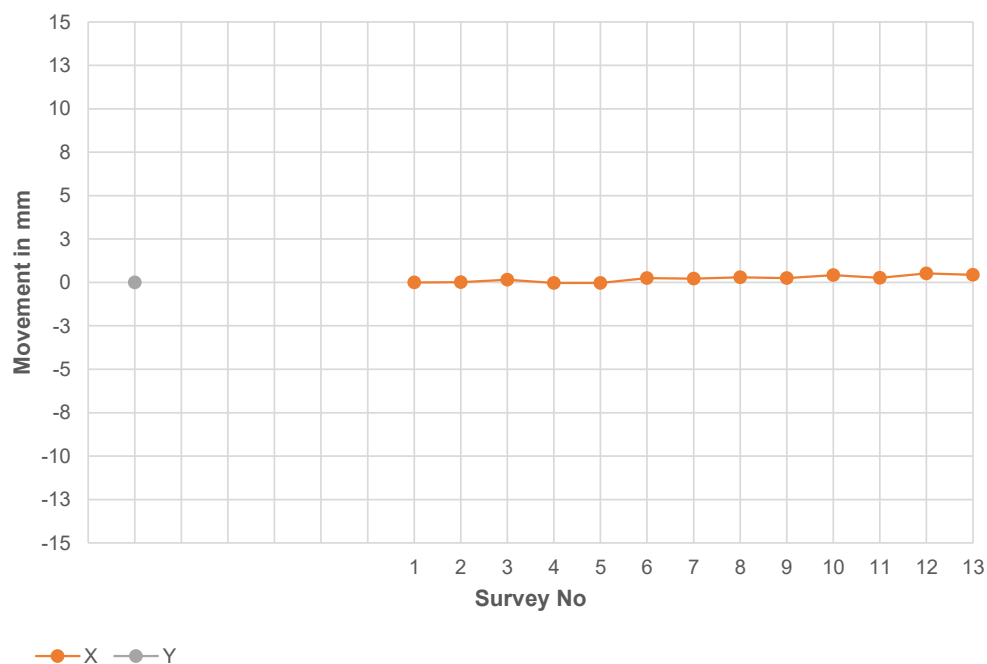
Ground - Top right of rear patio wall

| Survey No | Date | X | Y |
| 13 | 26/03/26 | 0.43 | |

| Gauge No | Gauge Type | Location Comment | Readings - Base | | Readings - Surveyed | | Differences | |
|---|---|---|---|---|---|---|---|---|
| D2 | Demec | Ground - Top right of rear patio wall | 26.29 | | 26.72 | | 0.43 | |

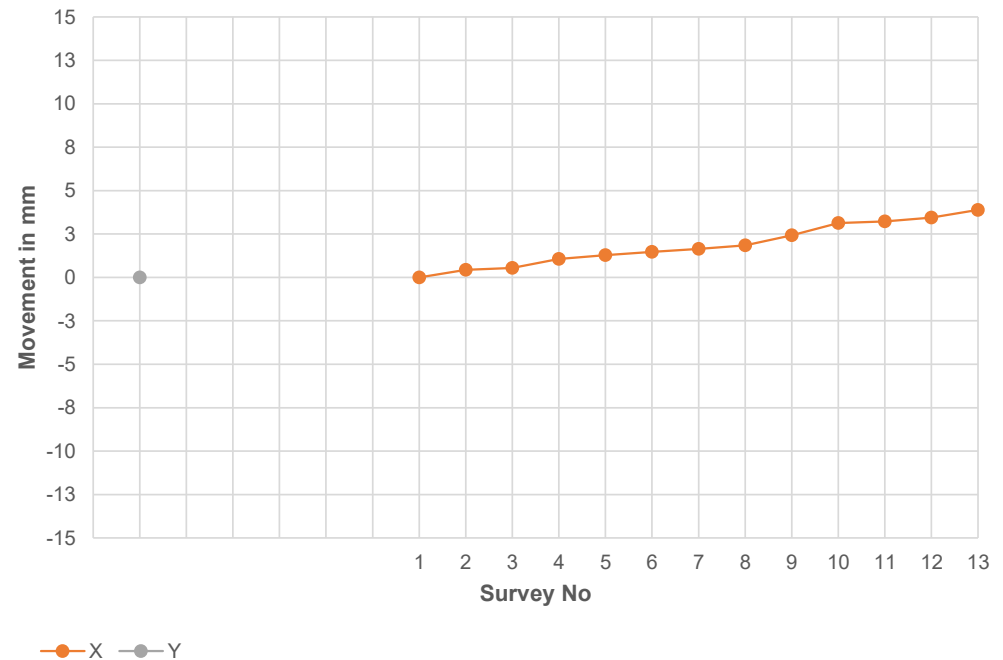
Ground - Kitchen wall to lounge

| Survey No | Date | X | Y |
| 13 | 26/03/26 | 3.89 | |

| Gauge No | Gauge Type | Location Comment | Readings - Base | | Readings - Surveyed | | Differences | |
|---|---|---|---|---|---|---|---|---|
| D1 | Demec | Ground - Kitchen wall to lounge | 53.77 | | 57.66 | | 3.89 | |
